AVRADCOM
Report No. TR 80-F-13

MANUFACTURING PROCESS DEVELOPMENT FOR DUST AND RAIN EROSION
RESISTANT COATED METALLIC CLADS FOR HELICOPTER ROTORS

D. P. Huey and A. R. Stetson
Solar/International Harvester
2200 Pacific Highway
San Diego, CA 92138

FINAL REPORT

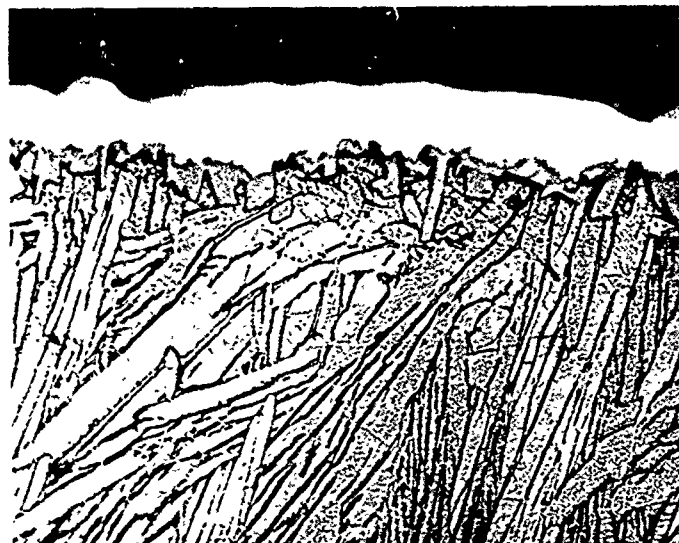
Figure 7.

Microstructure of Test
Piece Borided on Graphite
Forms
